**Township of West Windsor
Mercer County, New Jersey**

**Little Bear Brook Flood Hazard Assessment
Phase I – Little Bear Brook and Millstone River**

May 15, 2015

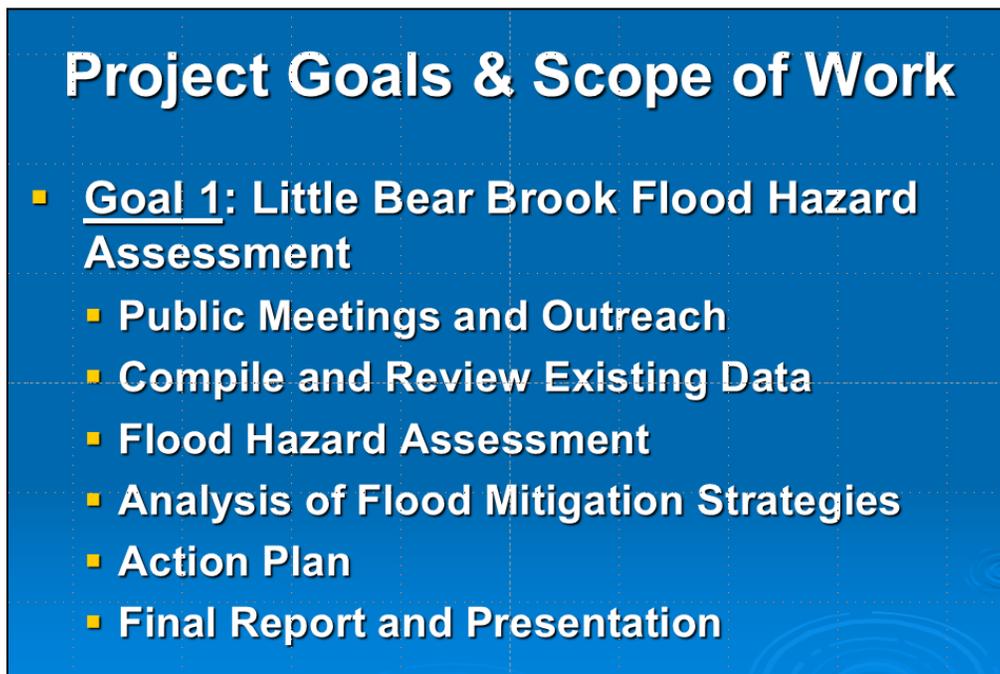
Figure 1
Phase I Scope of Work
Little Bear Brook Flood Hazard Assessment

A summary of the scope of work of Phase I of the Little Bear Brook Flood Hazard Assessment (identified as Goal 1 in the Township’s combined Flood Hazard Assessment and Regional Stormwater Management Plan) is presented in Figure 1 below. This information has been taken from a PowerPoint presentation on the progress of both Phase I of the Little Bear Brook Flood Hazard Assessment and the Regional Stormwater Management Plan given to the West Windsor Township Council and public on June 30, 2014. A copy of the Township’s entire February 2, 2012 Request for Engineering Services that details the original scopes of work for the Flood Hazard Assessment and Regional Stormwater Management Plan is contained in **Appendix A – West Windsor Request for Engineering Services**.

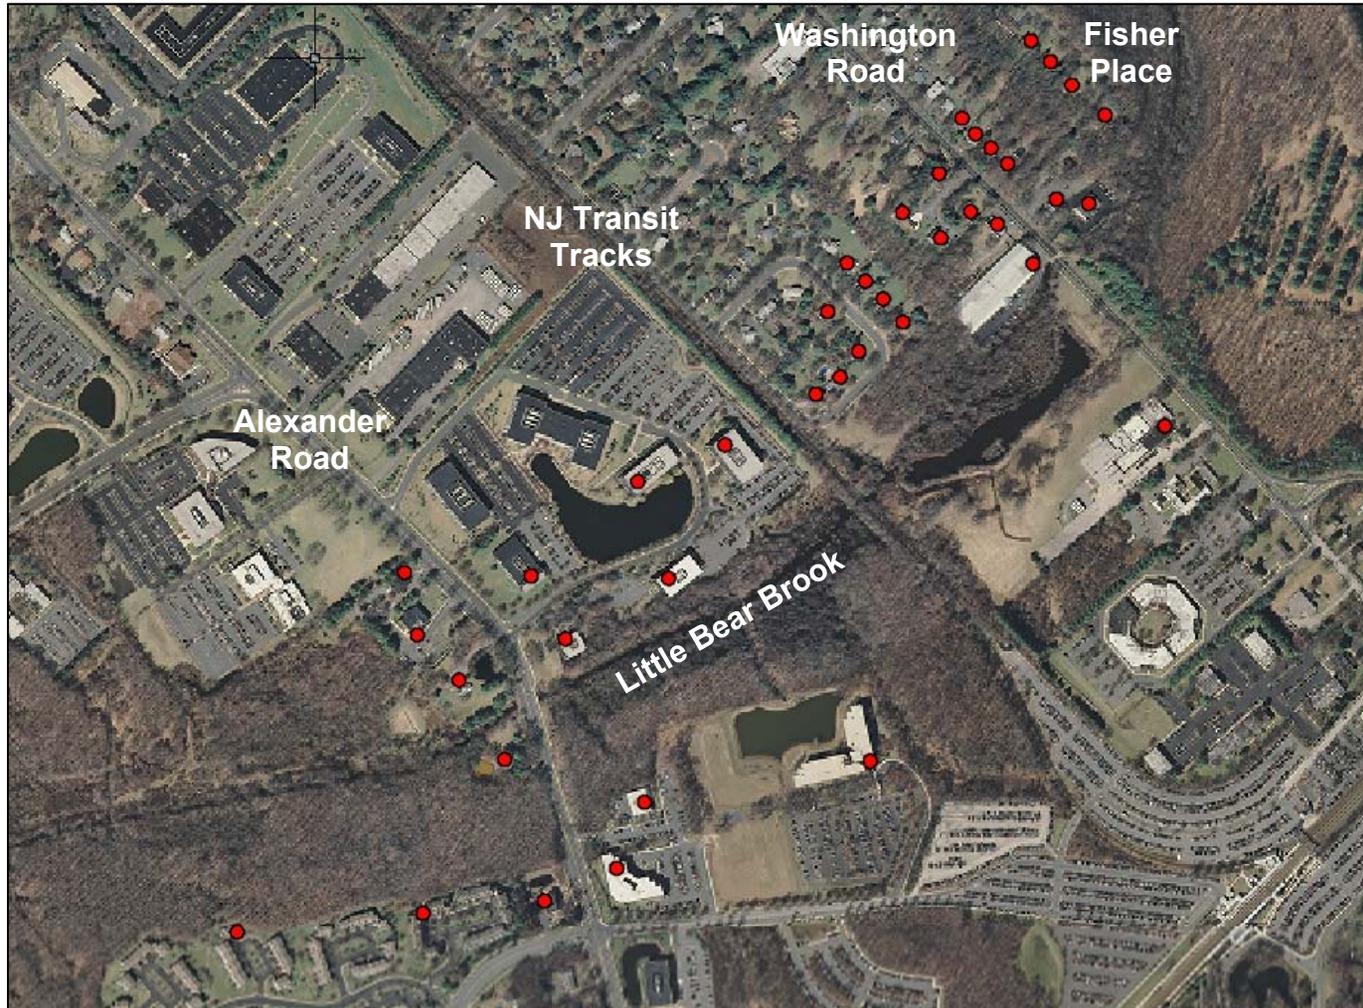
Figure 10
Location of Field Surveyed Structures in Little Bear Brook Floodplain
Little Bear Brook Flood Hazard Assessment

In addition to determining the various levels and frequencies of flooding, assessment of the flood hazard risk along Little Bear Brook required a determination of the elevations of the first above-grade habitable floors at key residential, office, and commercial structures within the Brook's floodplain. This was achieved by field surveying these elevations at 40 such structures. These field surveys were conducted by Pickering, Corts, and Summerson under contract to Princeton Hydro, LLC. The locations of these surveyed structures are shown in Figure 10 and in **Appendix E – Surveyed Structure Elevations**. A summary of the surveyed elevations at each a structure is also contained in **Appendix E**.

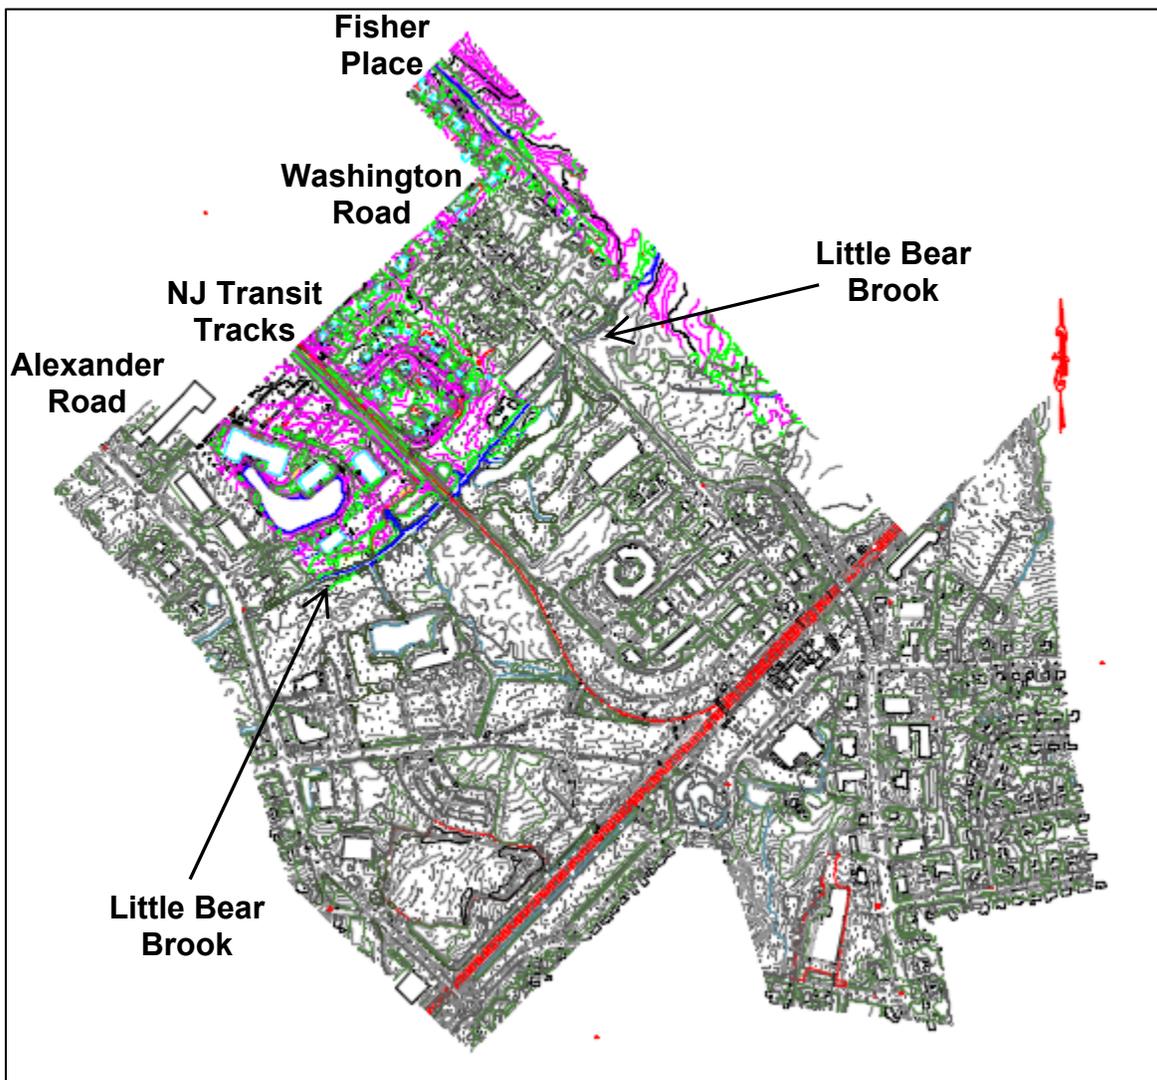
Figure 11
Limits of New Project Area Topographic Mapping
Little Bear Brook Flood Hazard Assessment

In addition to the U.S. Geological Survey 7.5-Minute Series topographic mapping of the Little Bear Brook and Millstone watersheds (as shown in Figures 2 and 8, respectively), topographic mapping was specifically developed for both the Flood Hazard Assessment and Regional Stormwater Management Plan project areas. This topographic mapping was based upon new 1 inch = 400 feet aerial photography flown in 2012 and was prepared at a 1-foot contour interval and a scale of 1 inch = 50 feet. The limits of this project area topographic mapping are shown in Figure 11.

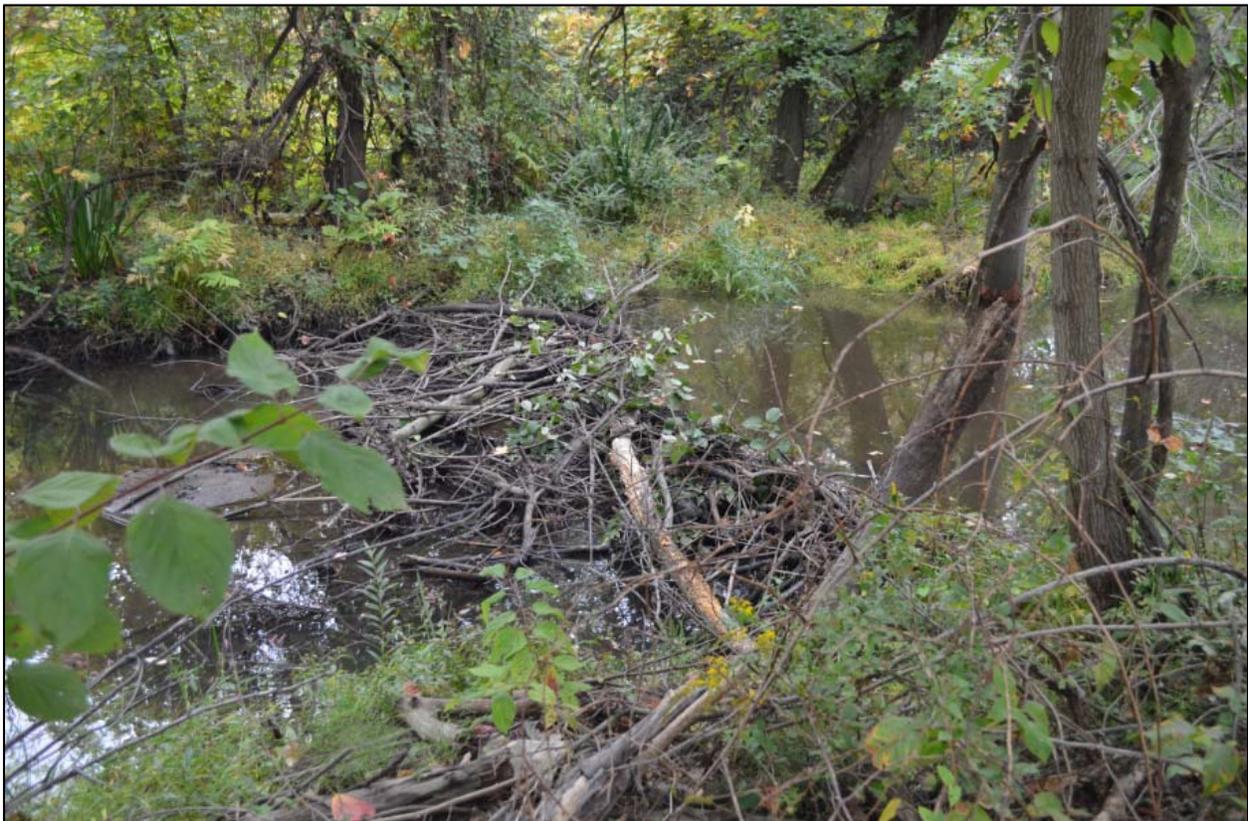
Figure 21
Beaver Dam in Little Bear Brook Channel Downstream of Washington Road
Little Bear Brook Flood Hazard Assessment

One such potential cause was first reported by the West Windsor Township Engineer and subsequently observed in the field during a reconnaissance of Little Bear Brook. As shown in Figure 21 taken approximately 100 feet downstream of Washington Road, this potential cause of flooding, particularly at Washington and/or Alexander Roads, was the creation of a beaver dam across the Little Bear Brook channel. Such dams can both raise the starting water surface elevation in the Brook prior to a flood event and decrease the flow capacity of the channel during an event.

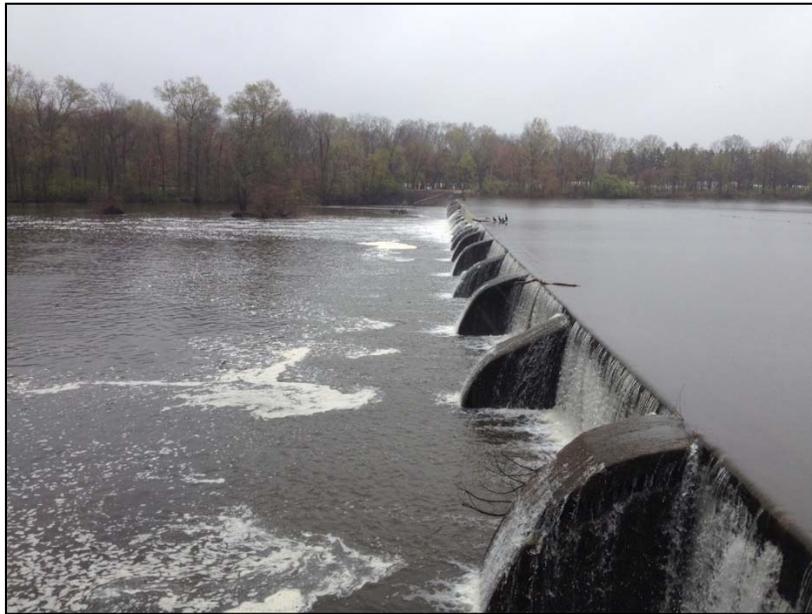
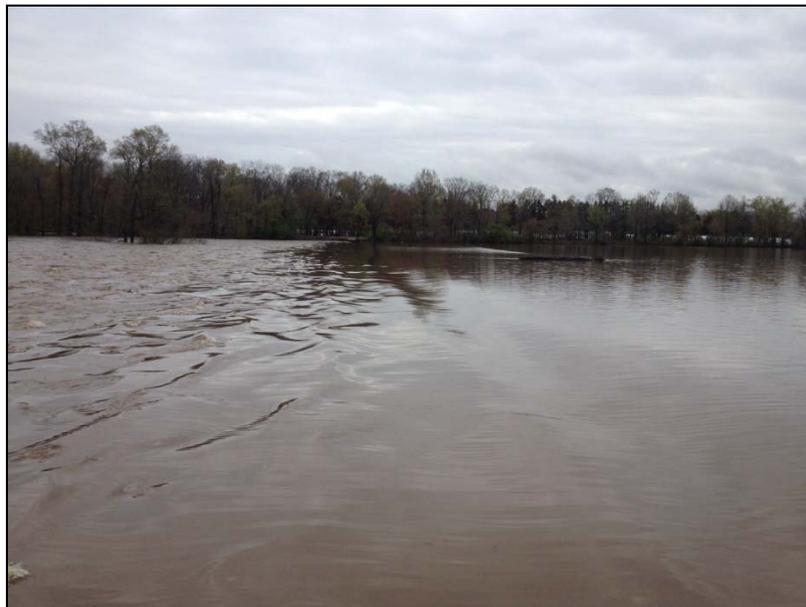
**April 30 – May 1, 2014 Flood Photographs – Millstone River at Carnegie Lake Dam
Little Bear Brook Flood Hazard Assessment**

Photograph 1 - Millstone River at Carnegie Lake Dam – April 30, 2014

Photograph 2 – Millstone River at Carnegie Lake Dam – May 1, 2014

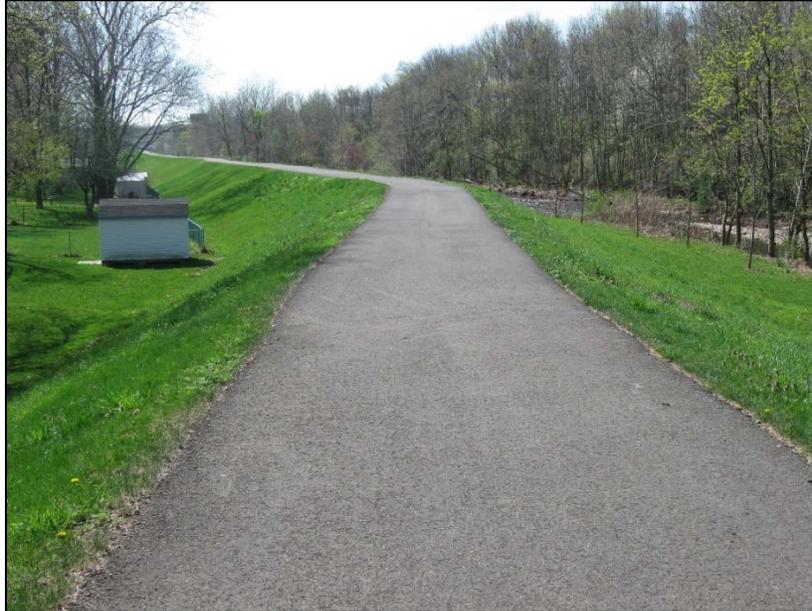
Figure 43
Green Brook Flood Control Project Levee
Little Bear Brook Flood Hazard Assessment

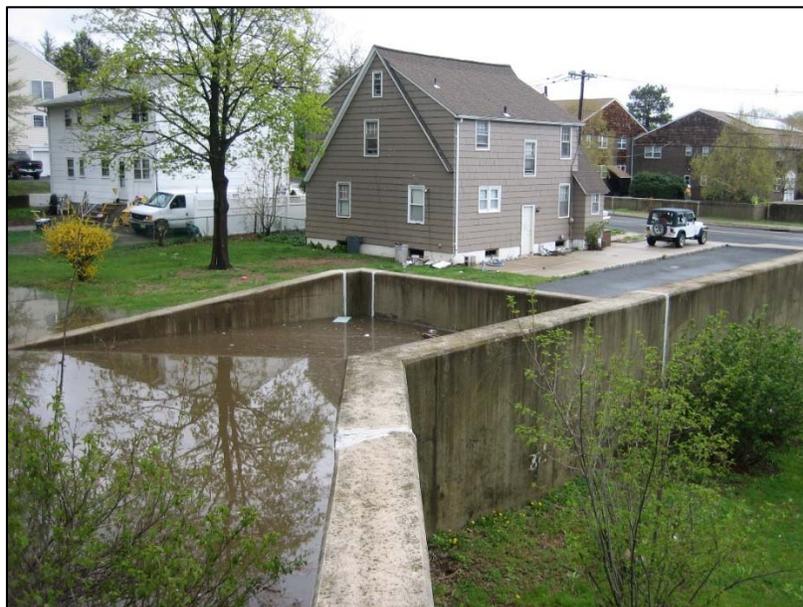
Figure 44
Green Brook Flood Control Project Floodwall
Little Bear Brook Flood Hazard Assessment

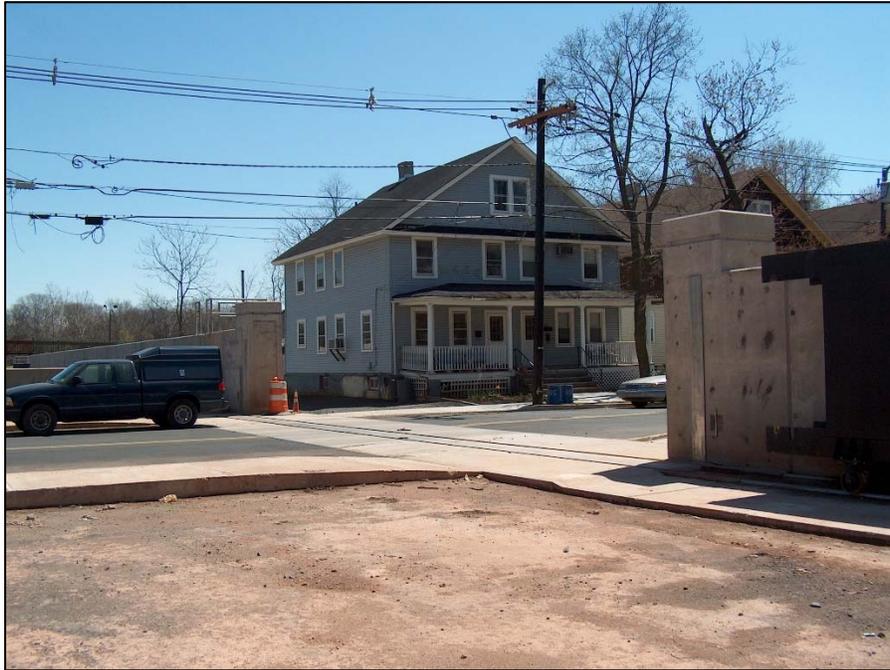
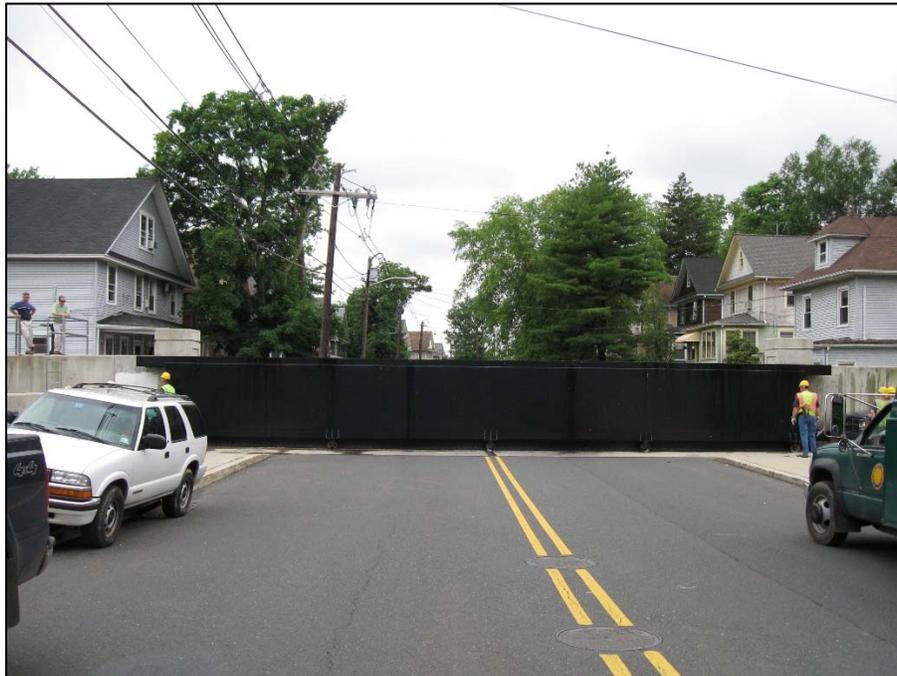
Figure 45
Green Brook Flood Control Project Roller-Type Closure Gate
Little Bear Brook Flood Hazard Assessment

Closure Gate in Open Position

Closure Gate in Closed Position

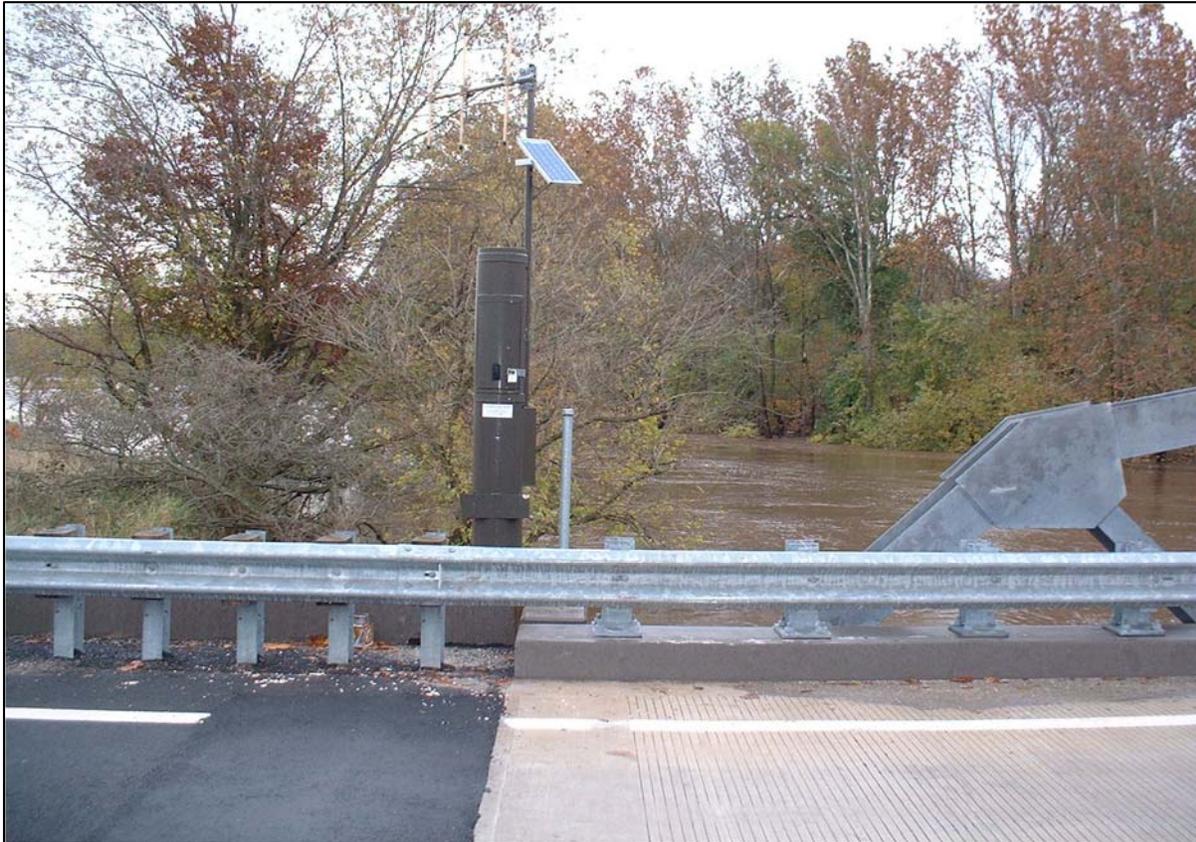
Figure 49
Photograph of a Remotely-Sensed Precipitation and Water Level Gage
Little Bear Brook Flood Hazard Assessment
